Major accidents involving contractors

MAHBULLETIN

Number 2 Dec 2012

CHEMICAL ACCIDENT PREVENTION & PREPAREDNESS

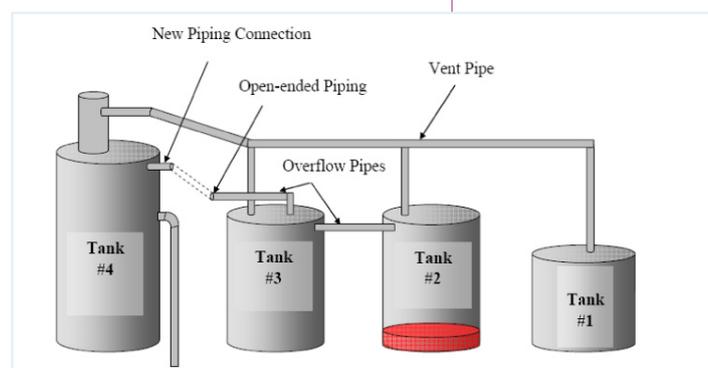
The incident occurred when contract workers were installing a new pipe connection from two storage tanks to a third storage tank (see image below). Welding sparks ignited flammable vapour escaping from an open-ended pipe about four feet (1.21 m) away from the contractors' welding activity on a fourth storage tank nearby. The explosion killed three workers and seriously injured a fourth one.

Tanks involved in the incident

Contractors were instructed to weld a pipe between two storage tanks (Tanks 3 and 4). To prepare for the welding operation, they removed the hatch at the base of Tank 4 and entered the tank to remove the crude oil residue. Then they flushed the tank with fresh water and allowed hydrocarbon vapour to evaporate for several days. They did not clean out or purge Tanks 2 or 3. On the day of the accident, one worker inserted a lit oxy-acetylene welding torch into the hatch

and then into the open nozzle on the opposite side of the tank to verify that all flammable vapour had been removed before welding, which is clearly an unsafe practice. The workers laid a ladder on the tank roof, extending it across the 4 feet (1.21 m) space between the two tanks (Tanks 3 and 4). Almost immediately after the welding operation began, flammable hydrocarbon vapour venting from the open-ended pipe attached to the adjacent tank (Tank 3) ignited. The fire, which immediately flashed back into Tank 3, spread through the overflow connecting pipe from Tank 3 to Tank 2 which then exploded. The lids of both tanks were blown off.

- A gas detector was not used to test for flammable vapour.

tanks containing hydrocarbons with a lit oxy-acetylene torch to determine the presence of flammable vapour is unsafe and extremely dangerous.

- The open pipe on the adjacent tank was not capped or otherwise isolated.
- A makeshift work platform—a ladder placed between the tanks—was used.
- All tanks were interconnected and some of the tanks contained flammable residue and crude oil.

- When two or more oil tanks are linked to each other, the connection pipes should be equipped with isolation valves to prevent the escape of flammable vapour.
- The company should develop and implement written procedures and provide contractor training to ensure safe work practices during hot work, tank cleaning and work at elevated locations. These measures would have assisted workers in identifying and eliminating hazards prior to beginning the welding operation.
