# U-233 Project Lessons Learned

## Caution Bulletin

**Bulletin Number:** ISO-LL-10-13

**Title:** Potential Defective Material – Eyewash Solution

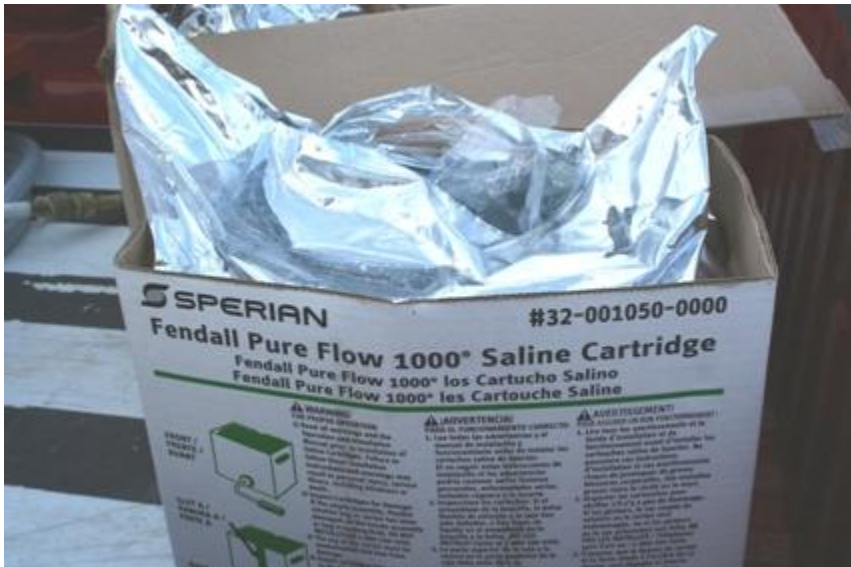
**Lessons Learned Statement:** Eyewash solution in factory-sealed cartridges may contain contaminants due to deteriorating coating materials. Cartridges should be inspected prior to installing in eyewash stations.

**Discussion of Activities:** On February 2, 2010, Hanford Pipefitters discovered that coatings on Fendall Pure Flow 1000 Saline replacement Cartridges have been found to be deteriorating and it is suspected that contaminants from the coatings may be in the eye wash solution. Units that currently have the cartridges installed may also be affected.

**Recommendations:** Inspect replacement eye wash solution cartridges before installing in eye wash stations.

Verify that eyewash solution cartridges currently installed in eyewash stations are safe for use.

If work activities require the use of an eye wash station, a different type of eye wash should be used until the potentially contaminated units are inspected and determined to be safe for use.
