ACCIDENT/INCIDENT ALERT

No.1, August 2005

Accident Involving a 3.5 kg CO₂ Extinguisher

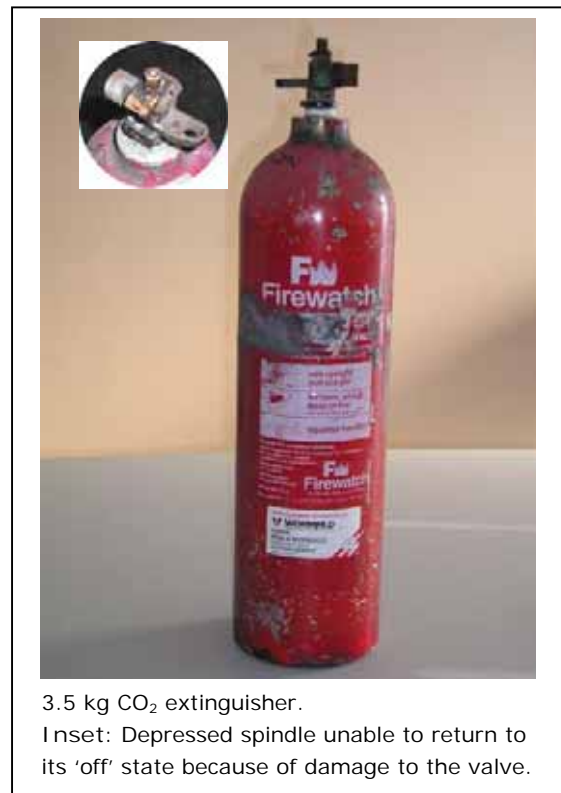
The partly disassembled CO₂ extinguisher was left in an elevated position from which it fell, landing on the exposed valve spindle causing the extinguisher to vent.

The valve body was damaged in the fall preventing the valve from self-closing. This resulted in a full discharge of the CO₂ extinguisher which had not been emptied before the hand piece was removed. Because the extinguisher did not have a horn the gas discharge was not diffused.

3.5 kg CO₂ extinguisher.

Inset: Depressed spindle unable to return to its 'off' state because of damage to the valve.

- The emptying, disposal and storage of out-of-service CO₂ extinguishers is carried out in consultation with the suppliers and service agents and specific procedures put in place to manage this hazard.
- Maintenance of CO₂ extinguishers is reviewed in consultation with the suppliers

and service agents and specific procedures put in place to manage this hazard.

- No employee maintains or carries out repairs to CO₂ extinguishers unless they are a:
 - Tradesman fitter with appropriate knowledge of the servicing of CO₂ extinguishers; or
 - Non-tradesman skilled person with the appropriate training in the skills and knowledge necessary for the servicing of CO₂ extinguishers.
- Out-of-service CO₂ extinguishers are discharged prior to being stored for parts.

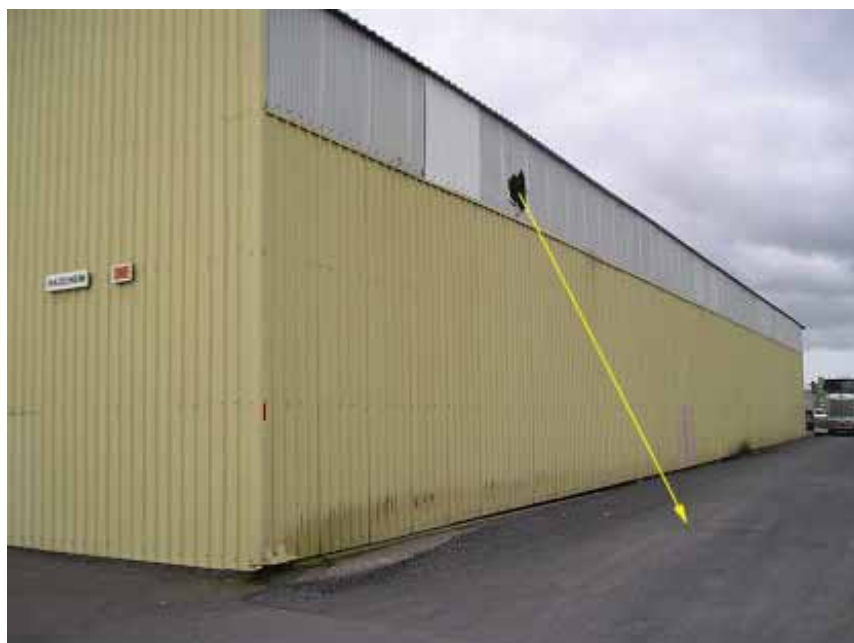
The uncontrolled continuous discharge of gas caused the extinguisher to spin on the ground, striking a worker's boot and inflicting a small puncture wound and a compound fracture to his ankle. The extinguisher was deflected and propelled 4.27 metres in an upward spiral, across an 11.5-metre distance striking the young woman in the head, resulting in her death. The extinguisher continued on its trajectory, punching a hole in perspex panelling at the top of the wall, to land outside.

Photo of the hole made by the extinguisher as it exited the building and the landing area to demonstrate the distance flown and force of the escaping gas.
