Dangerous Goods Safety Significant Incident Report No. 01-15

Aluminium powder dust explosion at explosives manufacturing plant

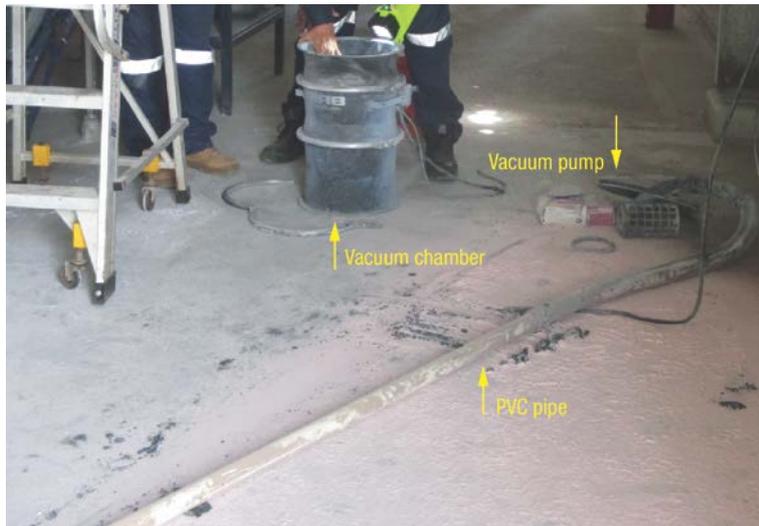
There was charring on the inside of both the vacuum chamber and transfer pipe work but not inside the hopper. It appears a dust explosion was triggered by a static discharge inside the vacuum chamber creating a flash-back through the transfer piping.

Damage to transfer system. Left. Vacuum pump chamber and pump, PVC transfer piping and evidence of spot fires on the floor. Right. Distortion of hopper caused by explosion.

- The inner and outer chambers of the pneumatically-driven vacuum pump were not effectively bonded and only one chamber was earthed. This allowed for the build-up of static electricity (a potential ignition source).
- Non-conductive PVC piping had been incorporated within the conductive transfer piping. The transfer piping was not earthed which allowed for the build-up of static electricity.

- Changes to plant and transfer piping that differ from the original plant specification constitute a design change. Before changes are made they should be carefully considered using a change management approach.
- Reduce the potential to generate a static charge by:
 - selecting a suitable low-energy transfer system for product (e.g. avoid high-energy pneumatic systems where possible)
 - using conductive material to assist in the dissipation of static charge (e.g. avoid non-conductive materials such as PVC)
 - effectively bonding and earthing plant and transfer piping.
